SUBJECT: Report No. 06-04B, "Transportability Testing of the Joint Modular Intermodal Platform (JMIP) #2", TP-94-01, "Transportability Testing Procedures"

**FINAL REPORT  
NOVEMBER 2006**

**REPORT NO. 06-04B**

**TRANSPORTABILITY TESTING OF THE JOINT MODULAR  
INTERMODAL PLATFORM (JMIP) #2,  
TP-94-01,  
“TRANSPORTABILITY TESTING PROCEDURES”**

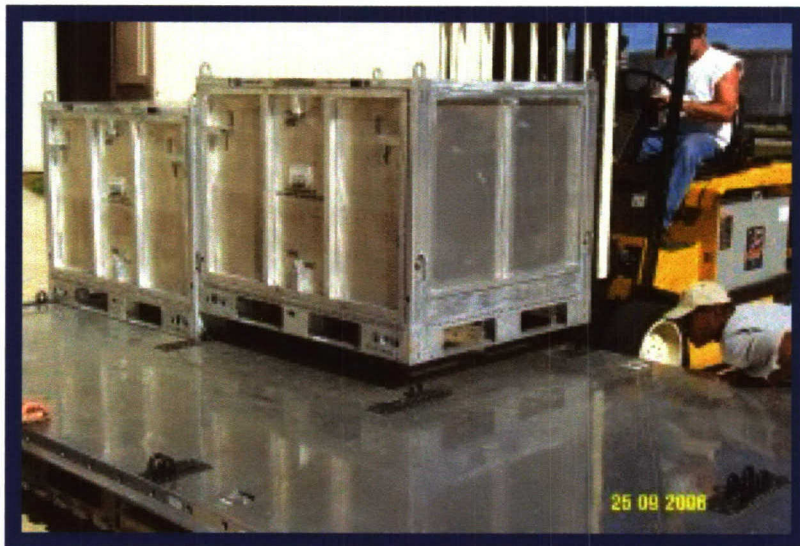
**Photo 3. Loading JMICs on JMIP #2.**

2. The interface rings that secured the JMICs to JMIP #2 did not have a positive lock to hold them in the upright position. Prior to testing one ring would not stay in the upright position. When loading the JMIC at that position the ring had to be held in the upright position using a string. Extreme care must be taken to ensure that the rings stay in the upright position when the JMICs are loaded onto the JMIP #2.

3. The JMIPs will have to be loaded in a sequence so that the rings will remain visible to personnel to ensure proper engagement. For instance, we started at the rear of JMIP #2 and loaded one side completely going from the rear to the bail bar end. The remaining four JMIPs were loaded onto the other side from the bail bar end to the rear of JMIP #2.

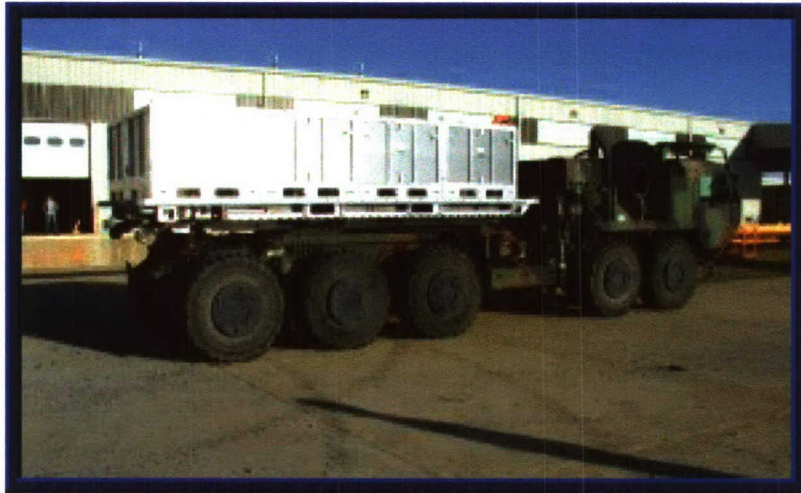
**Photo 5. Loaded JMIP #2 on the PLS Truck**

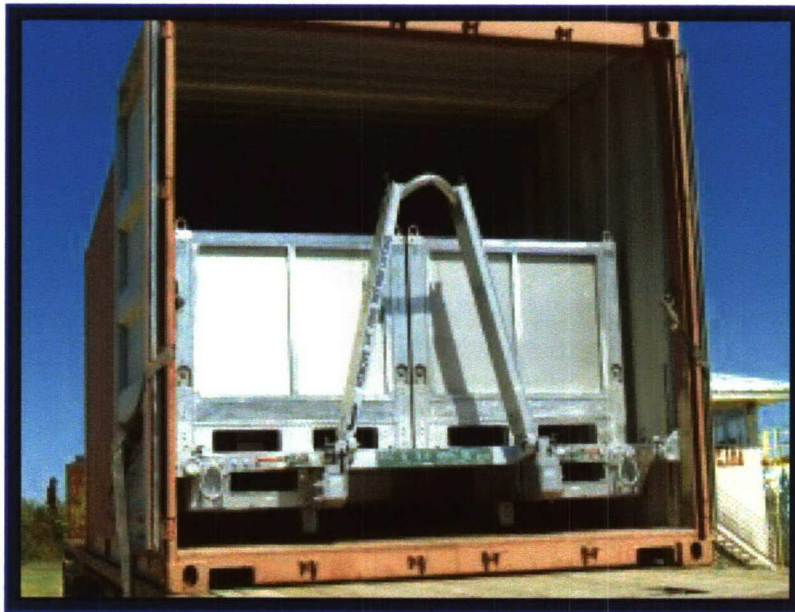
**Photo 10. JMIP #2 in the Intermodal Container**

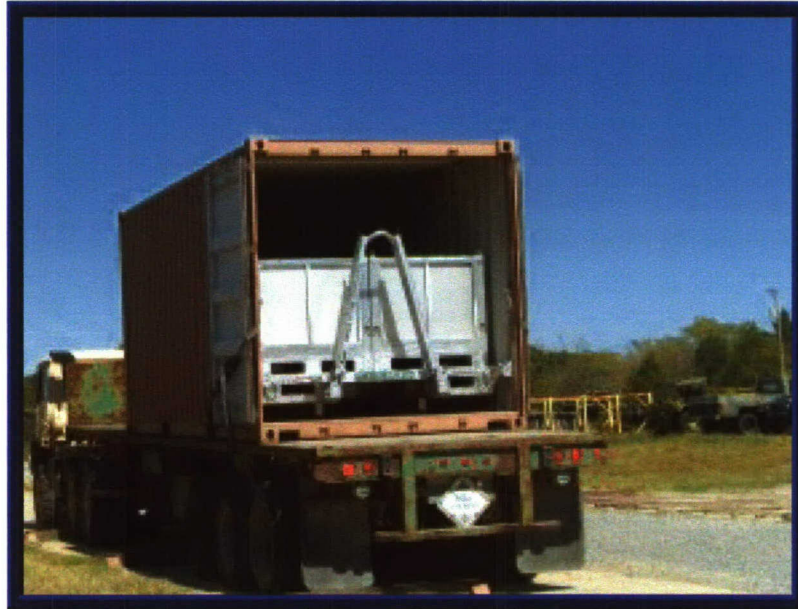
**Photo 11. Hazard Course Testing of JMIP #2 in the Intermodal Container.**

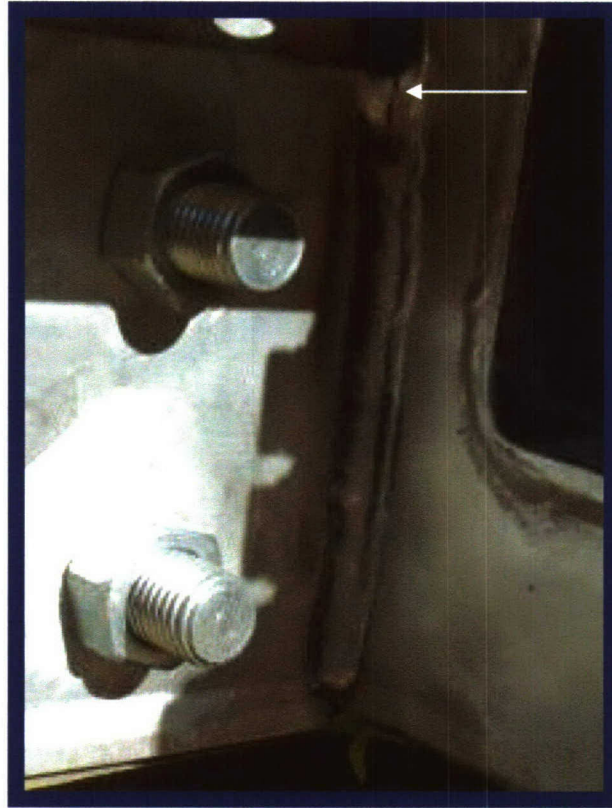
3. Final inspection revealed a cracked weld where the A-frame rail assembly connects to the right front forklift pocket.

**Photo 13. Cracked Weld.**
